**Environmental Management Plan
For Former Mullumbimby Hospital
Lot 188 DP728535, Lot 138 DP755722 and
Lot 1 DP1159861,
1-3 Azalea St, Mullumbimby NSW 2482**

Executive Summary

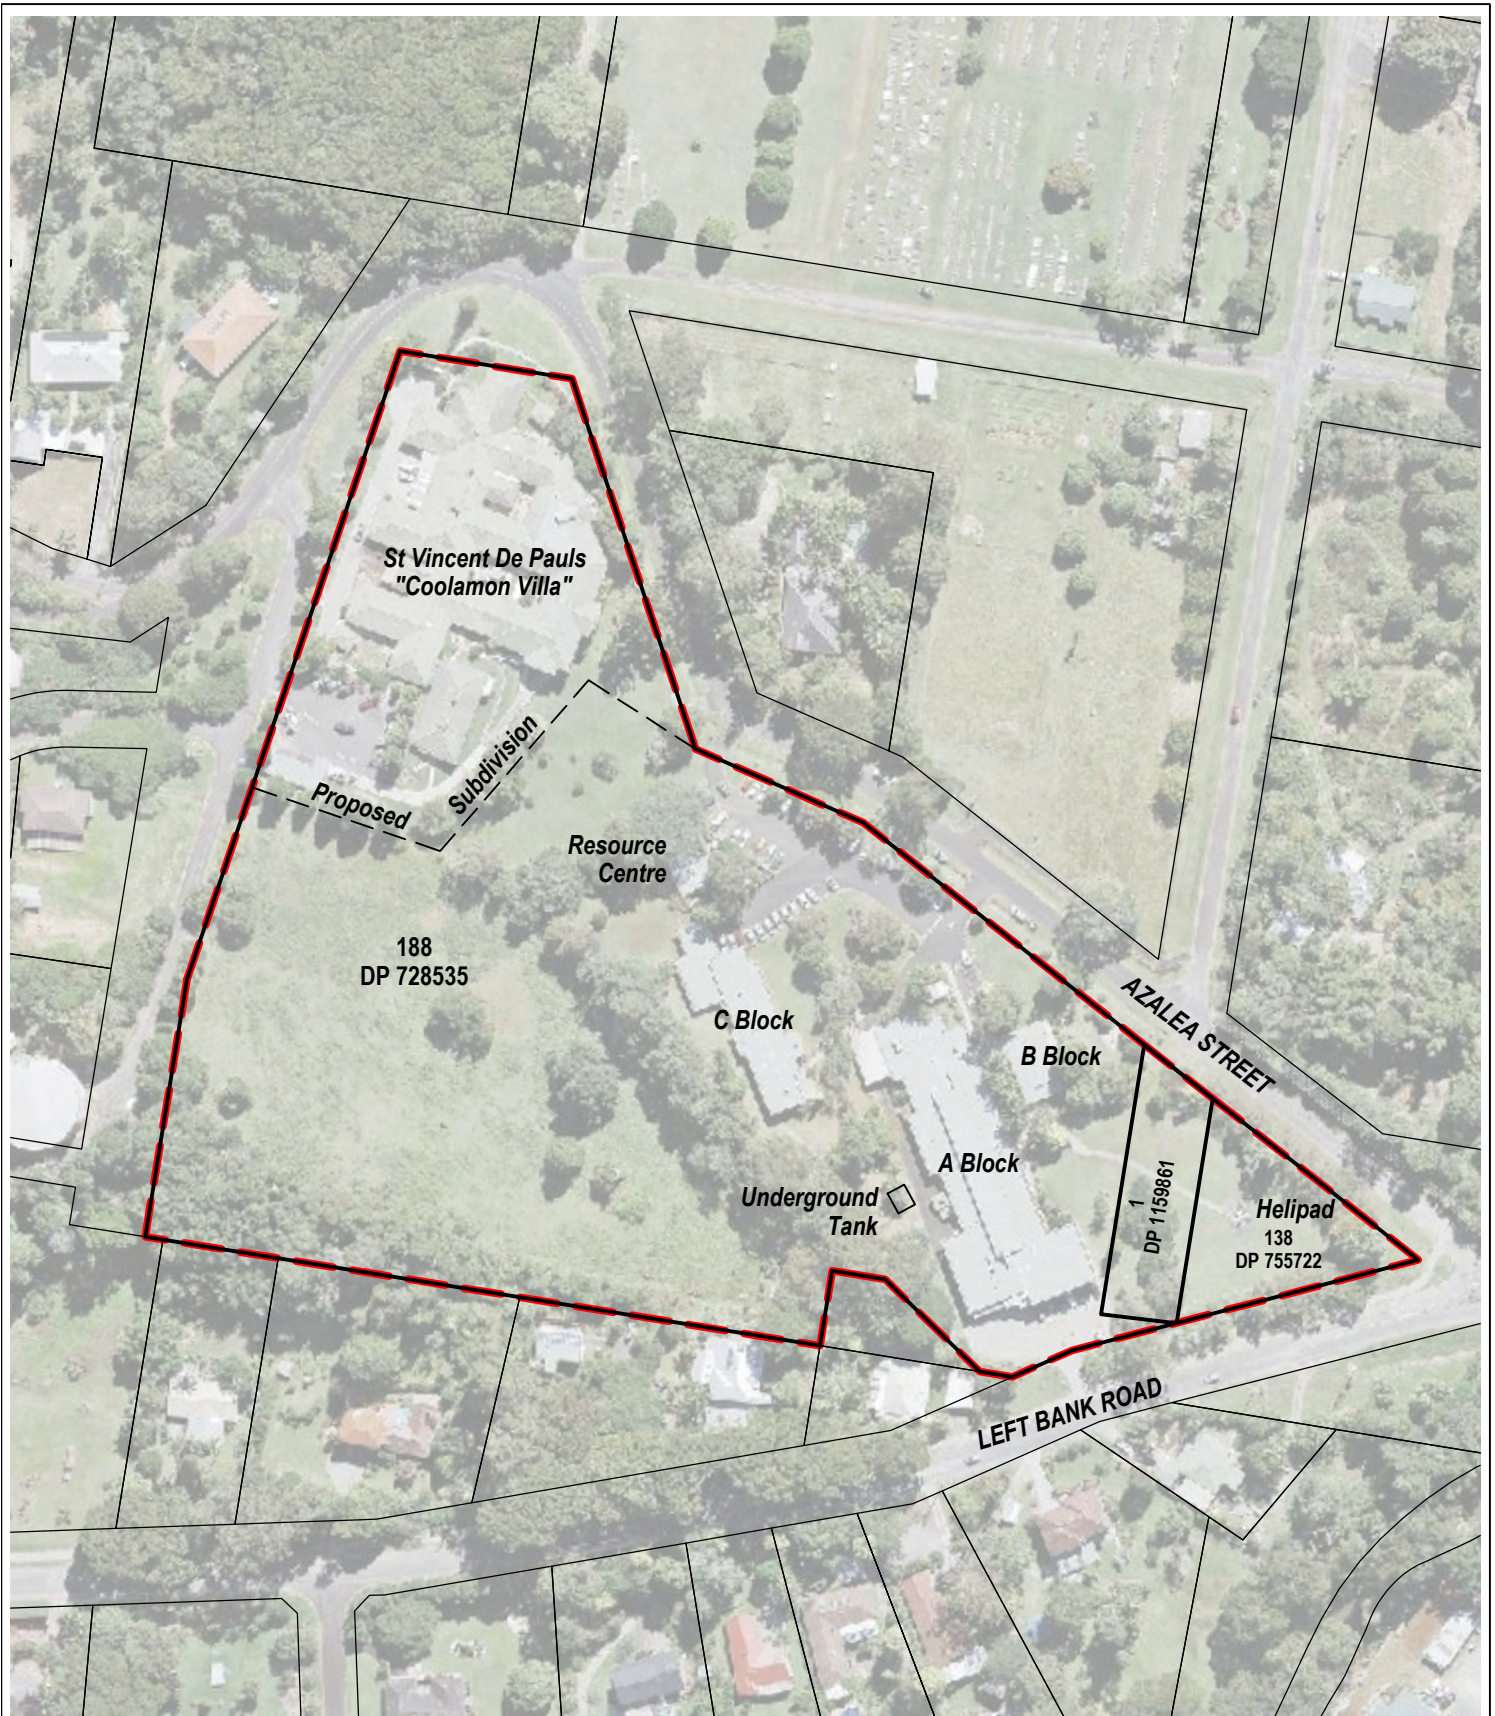
Title: **SITE PLAN WITH HOSPITAL LAYOUT**
Figure A2

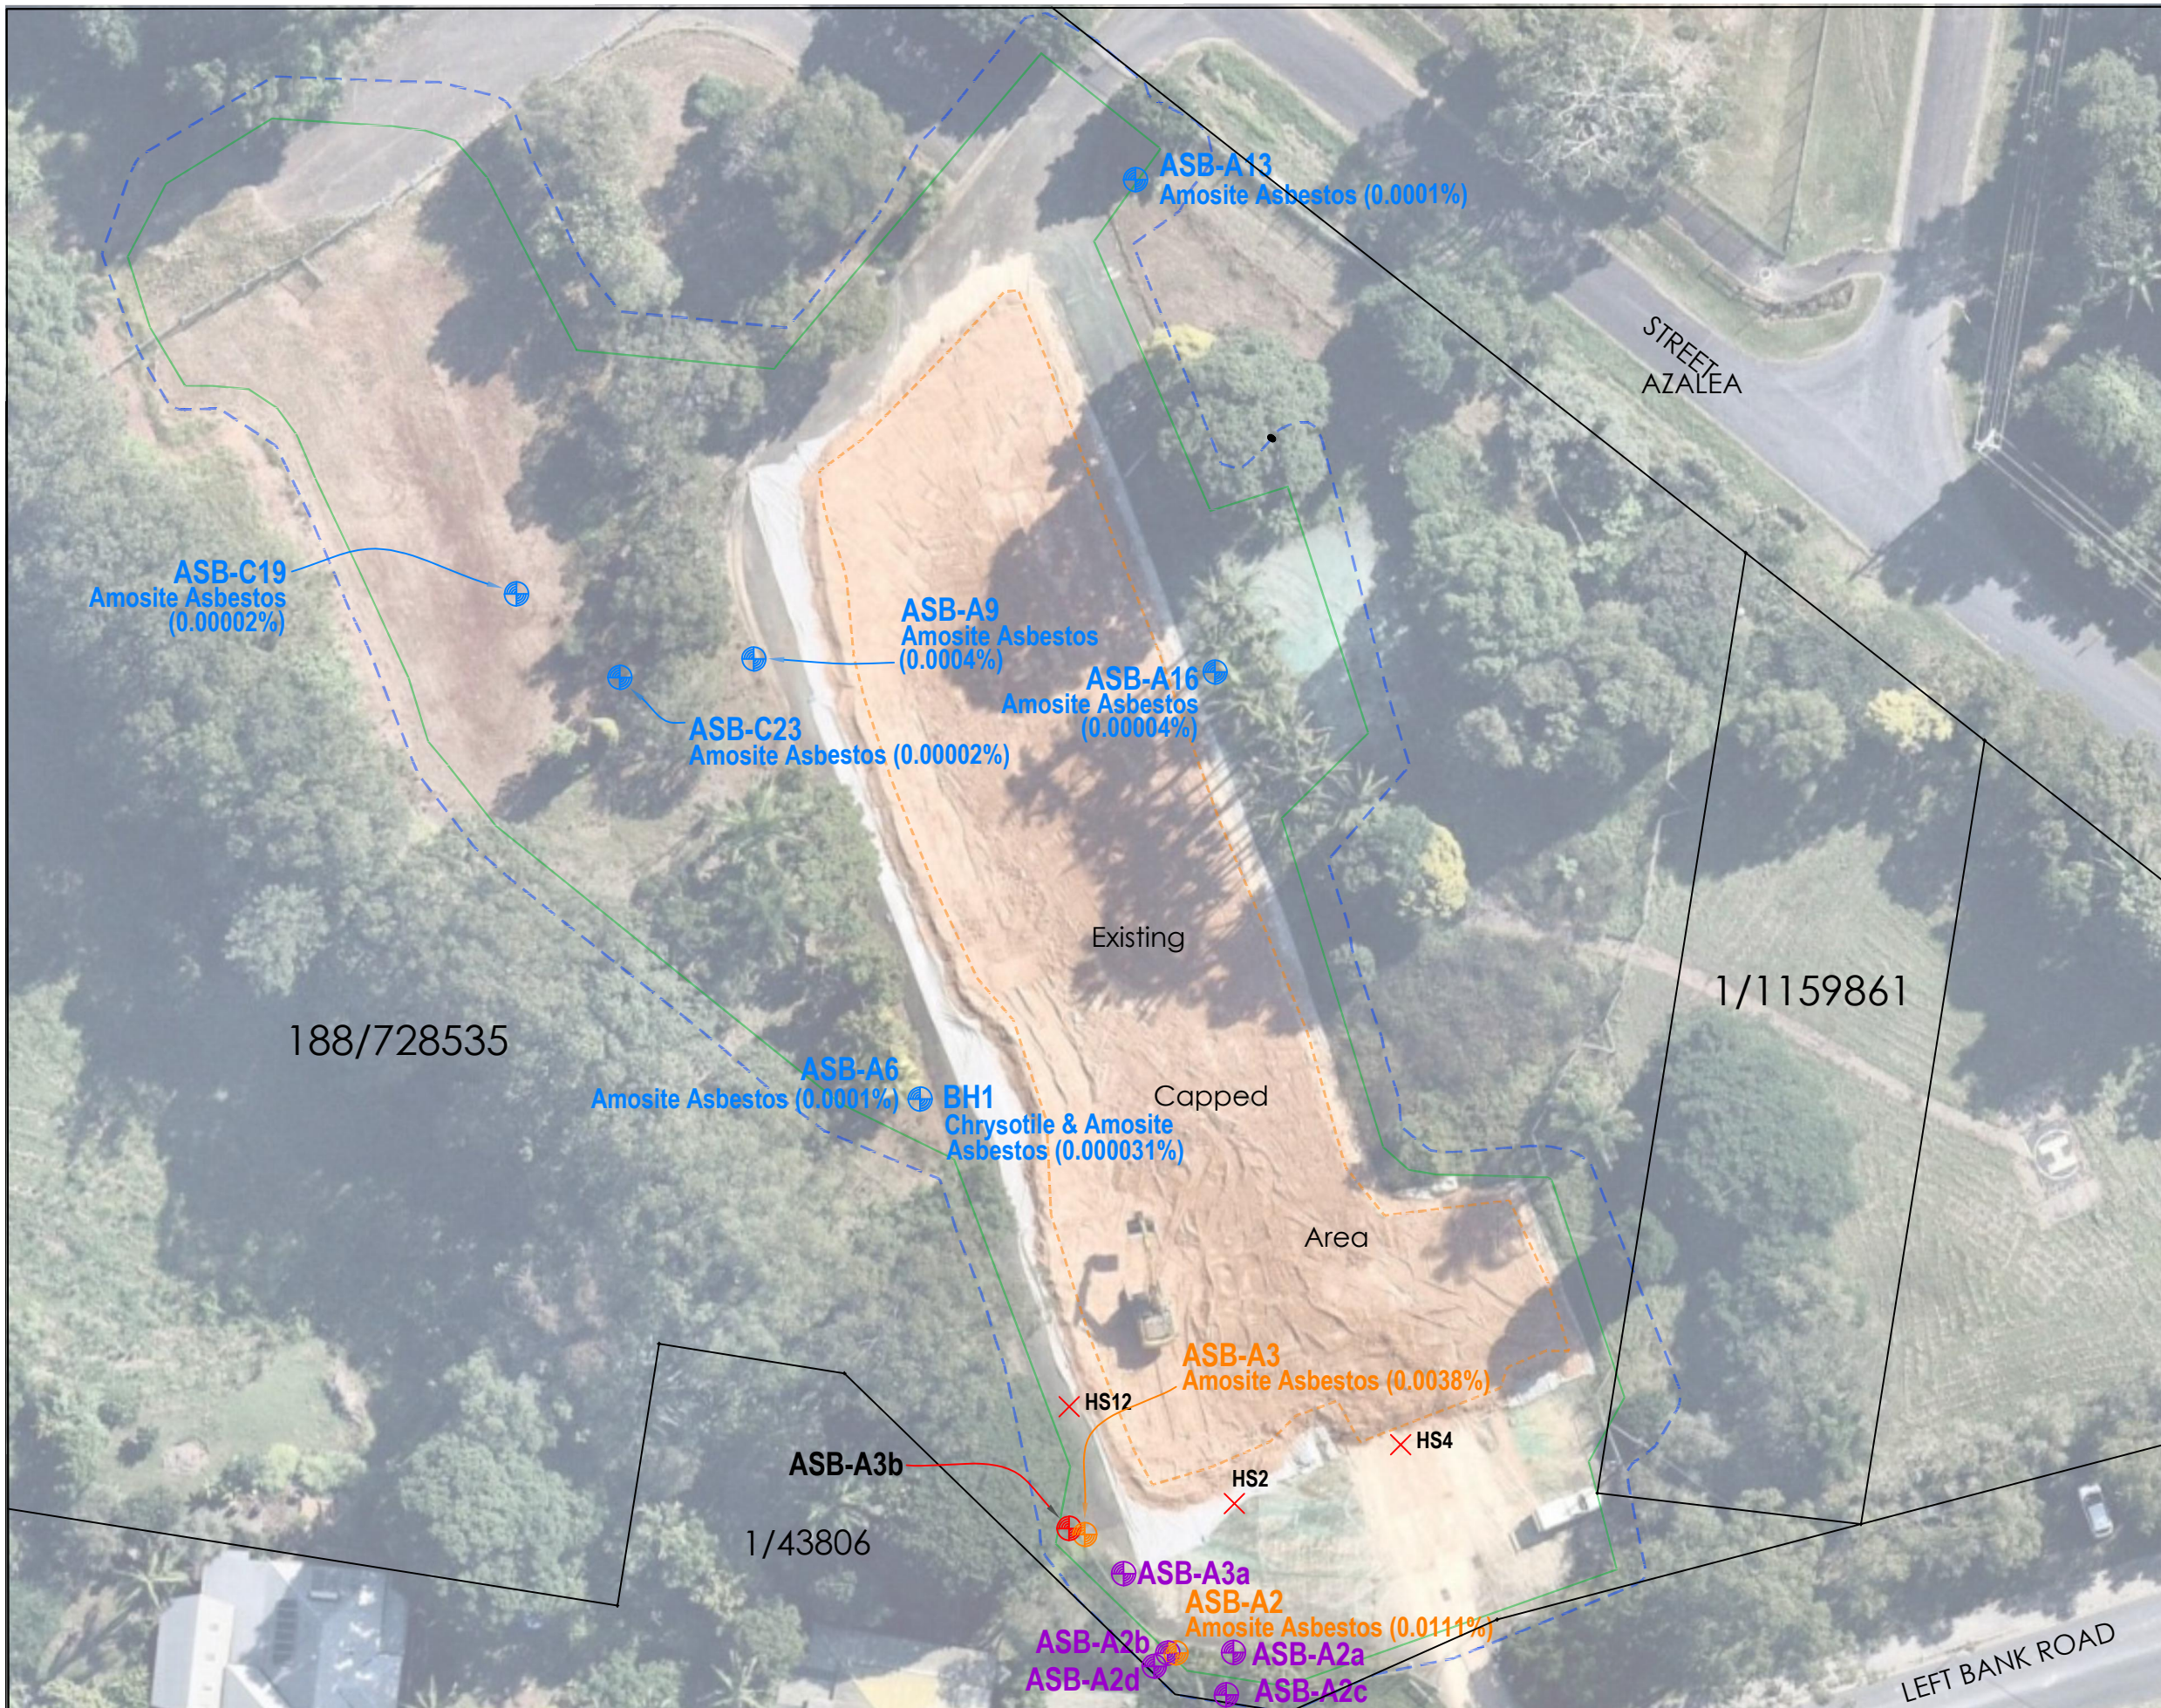
- Boundary
- Major contour
- Minor contour
- Top of Bank
- Bottom of Bank
- BSC Central Capped Area
- Design Limit

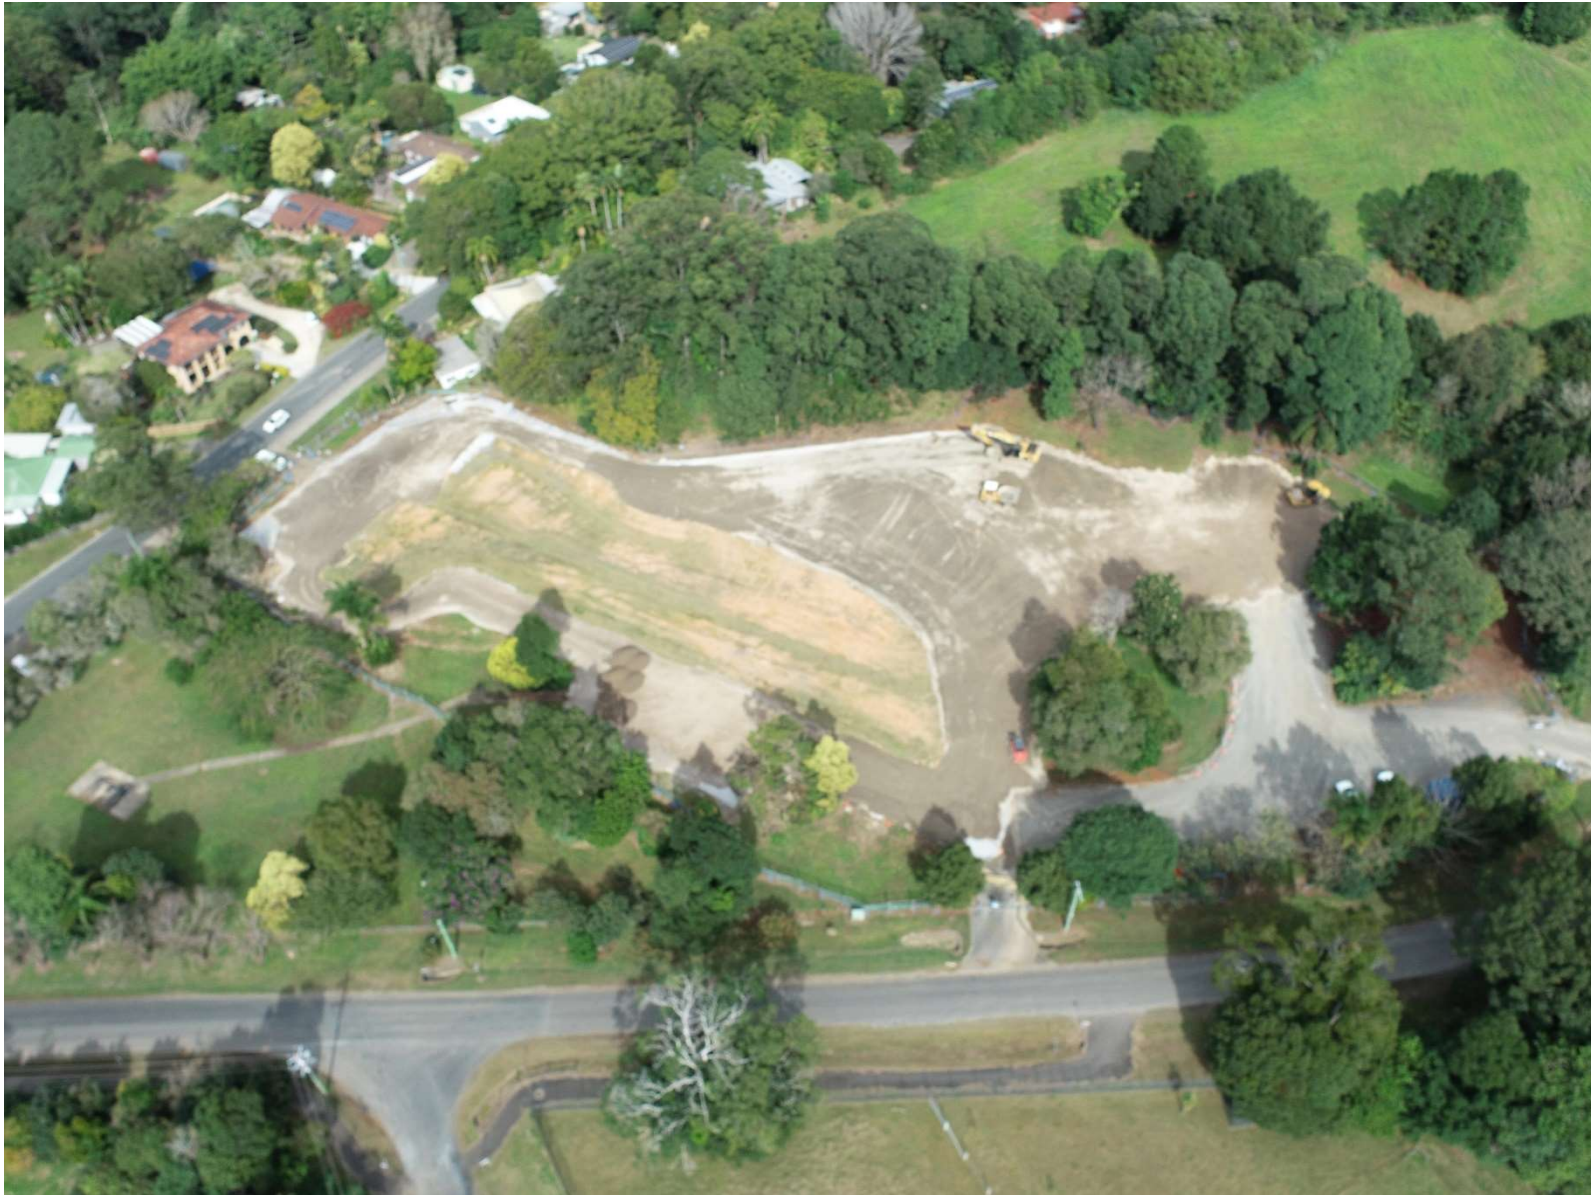
Plate B1. Drone photography of Site (4th August 2022)

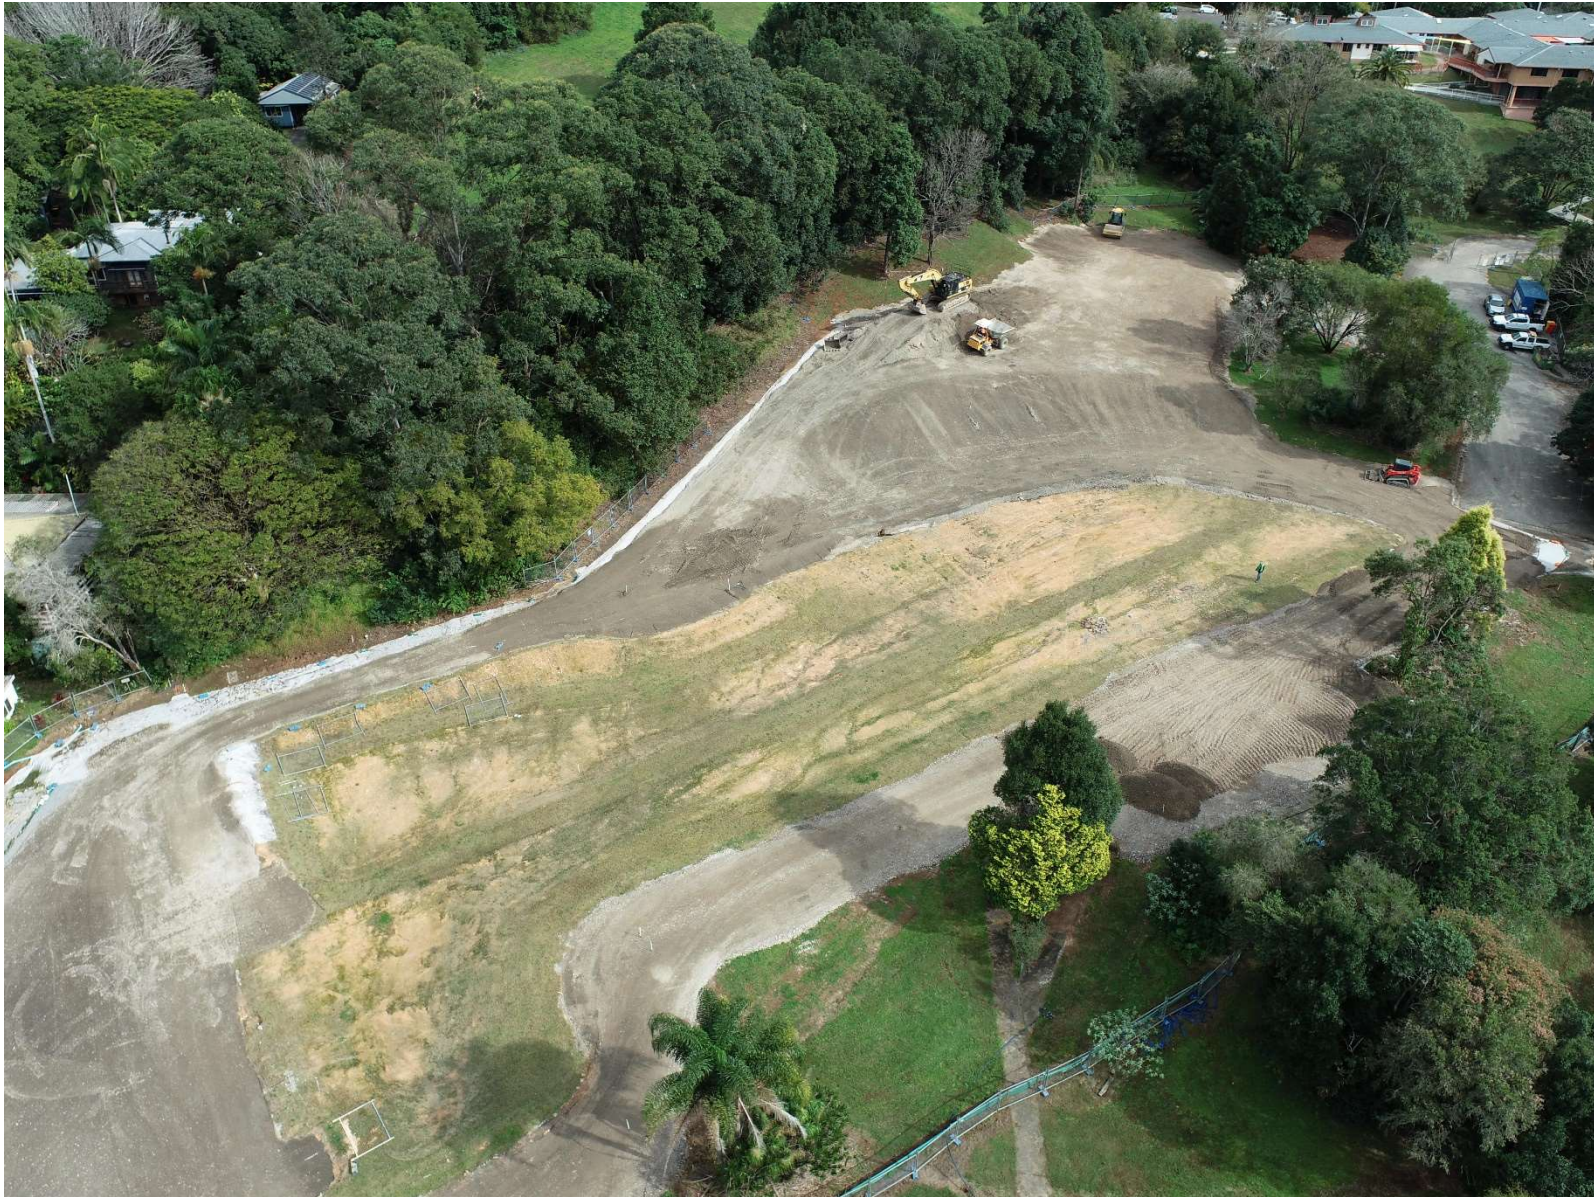
Plate B2. Drone photography of Site (4th August 2022)

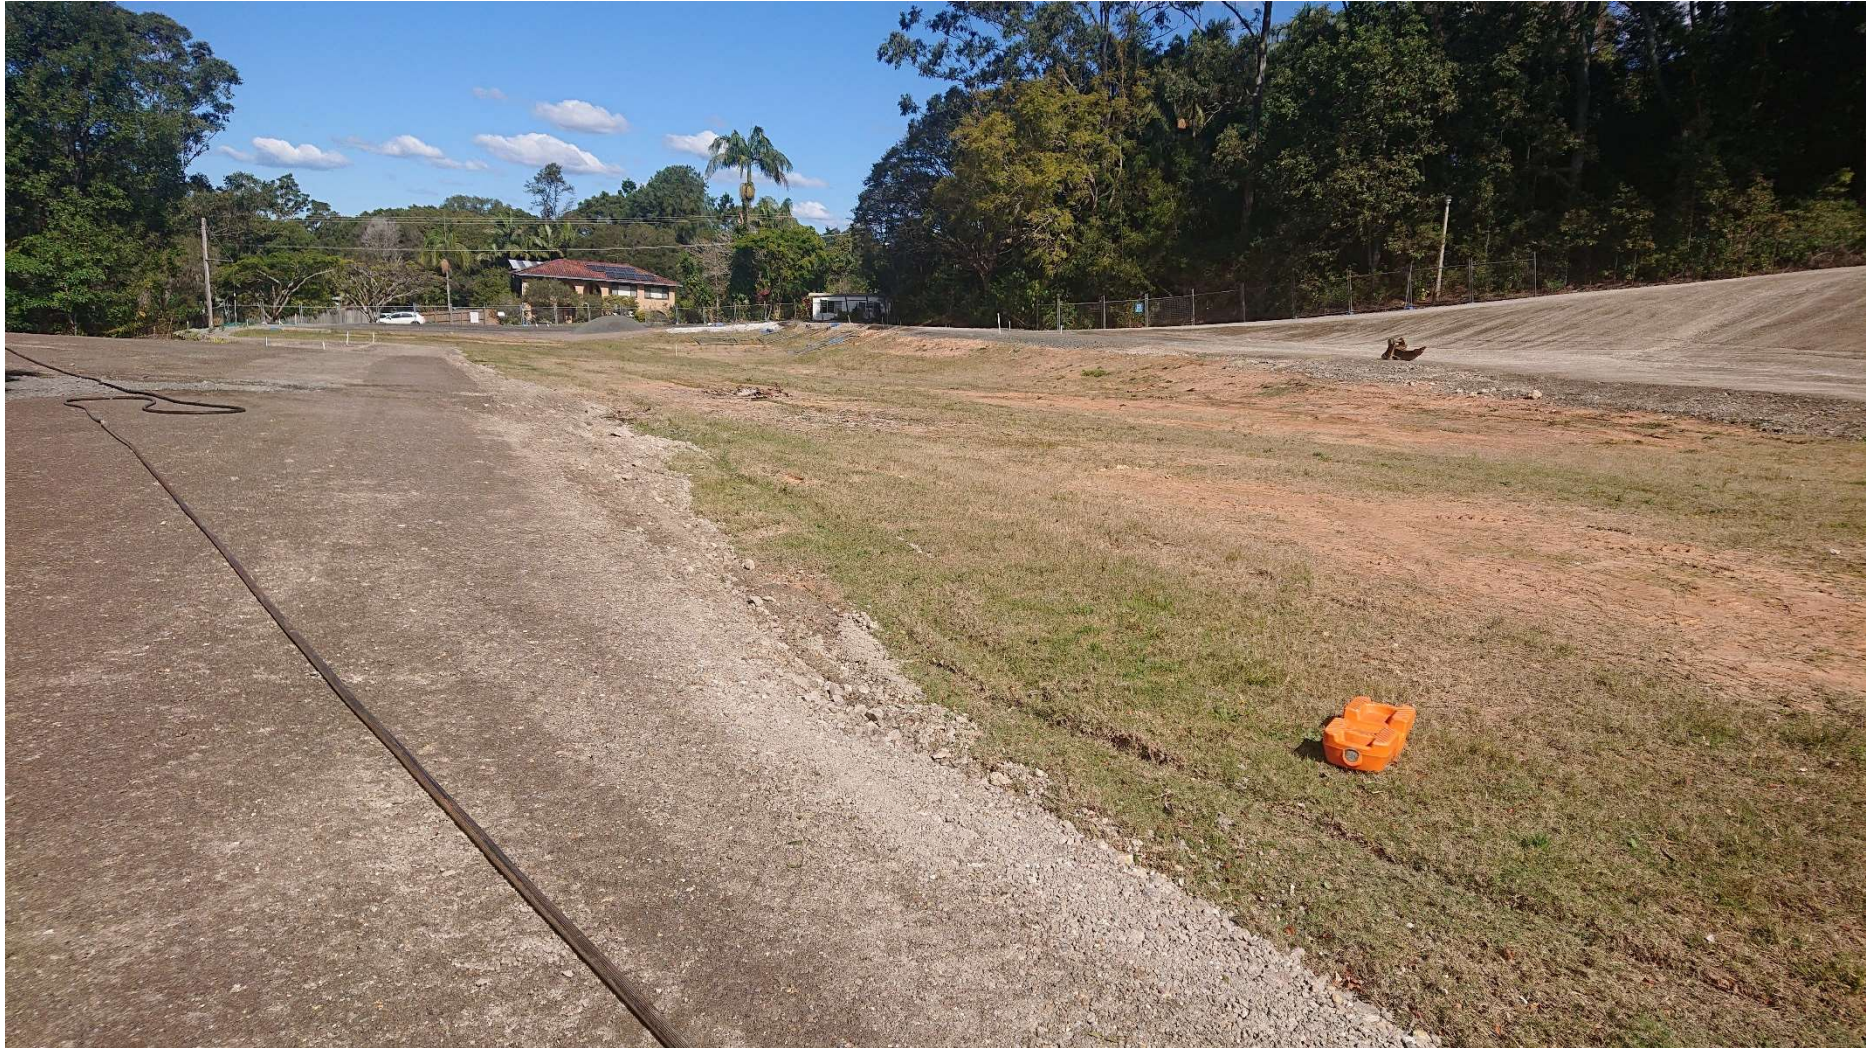
Plate B3. Southerly view of encapsulation area (16th August 2022) (grass area is with Block A)

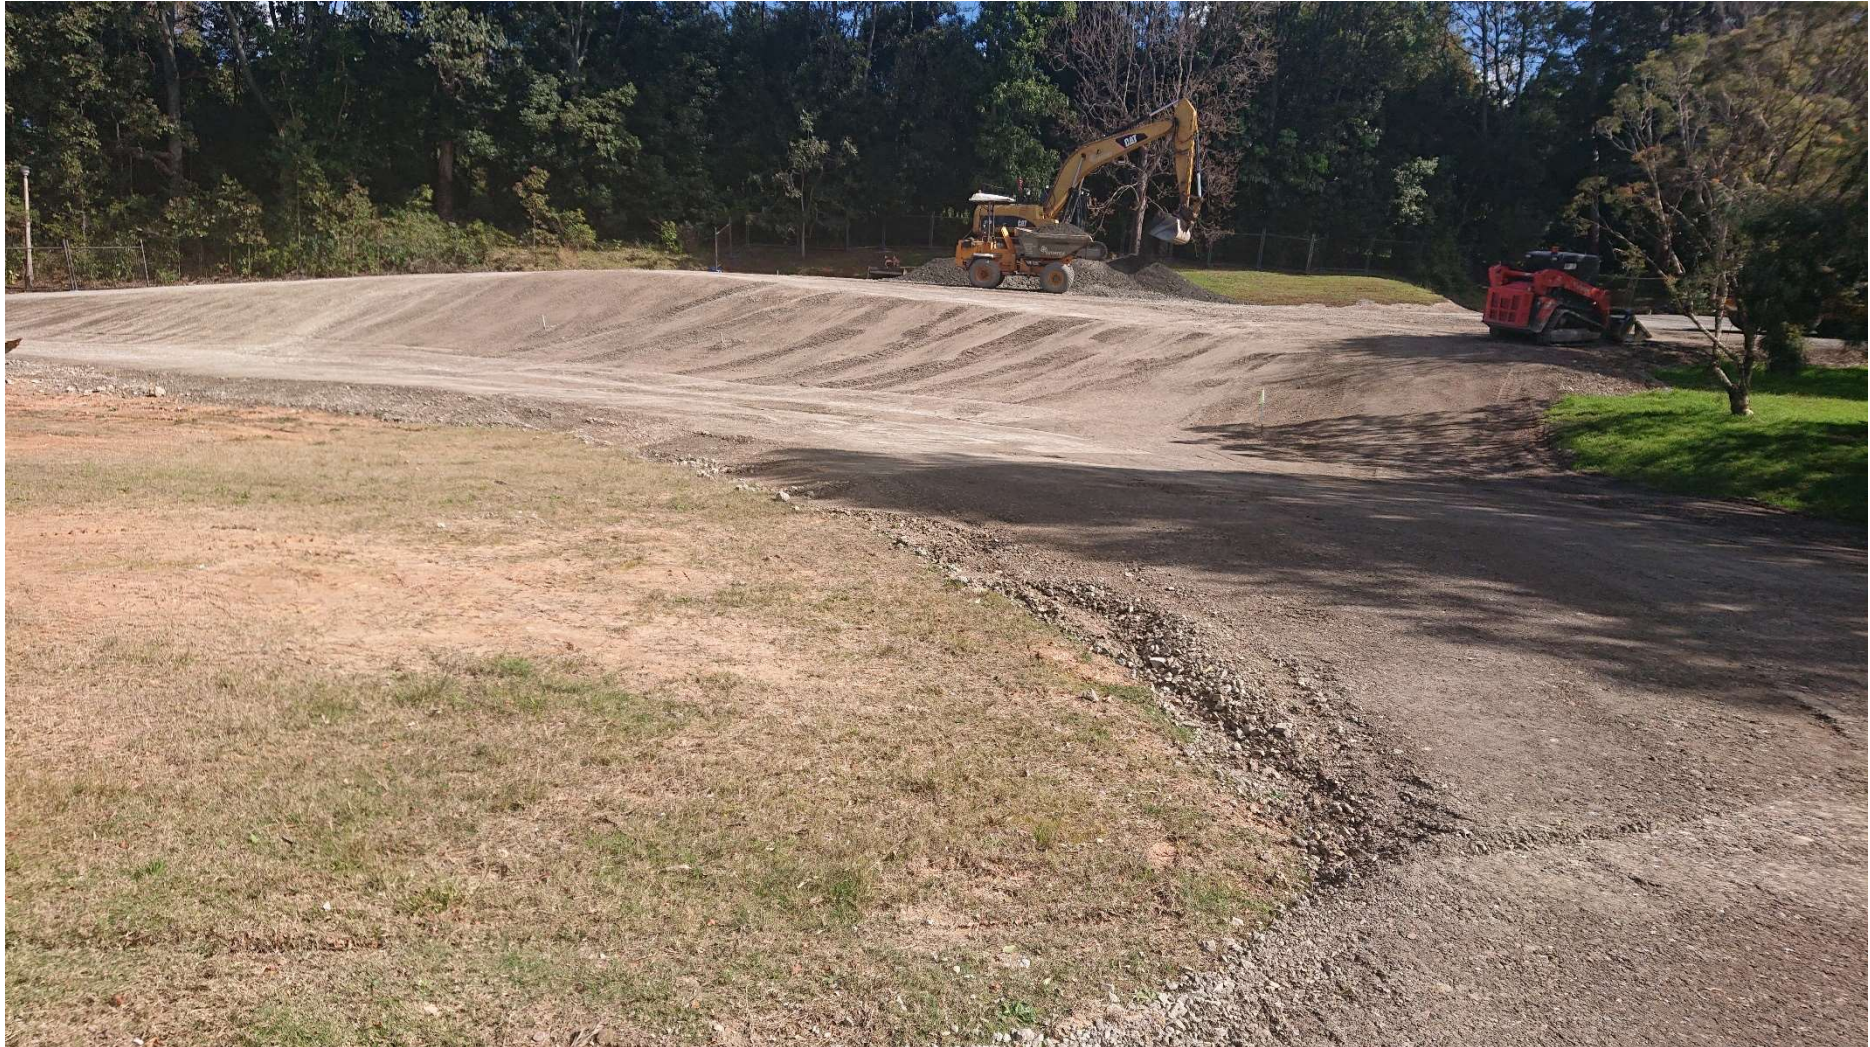
Plate B4. Westerly view of northern section of encapsulation area at end of Block A with Block C in background (16th August 2022)

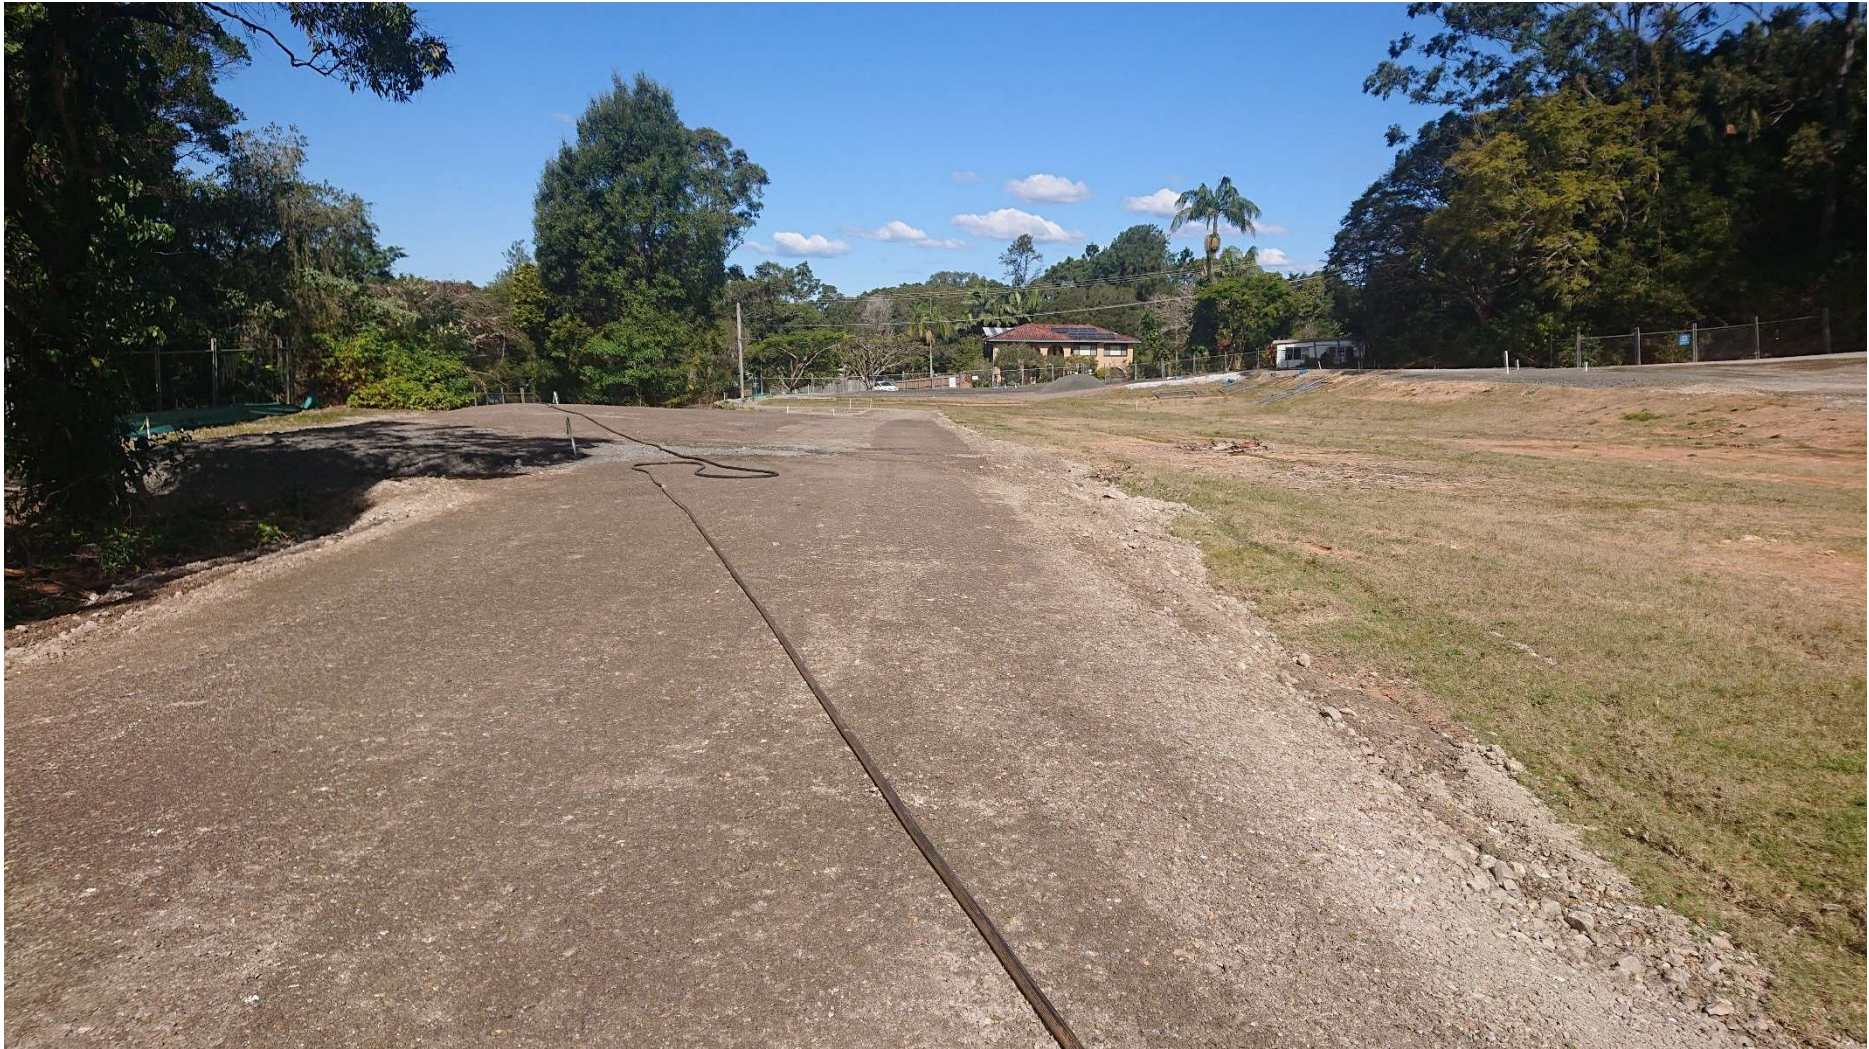
Plate B5. Southerly view of eastern section of encapsulation area with part of Block B visible (to left) (16th August 2022)

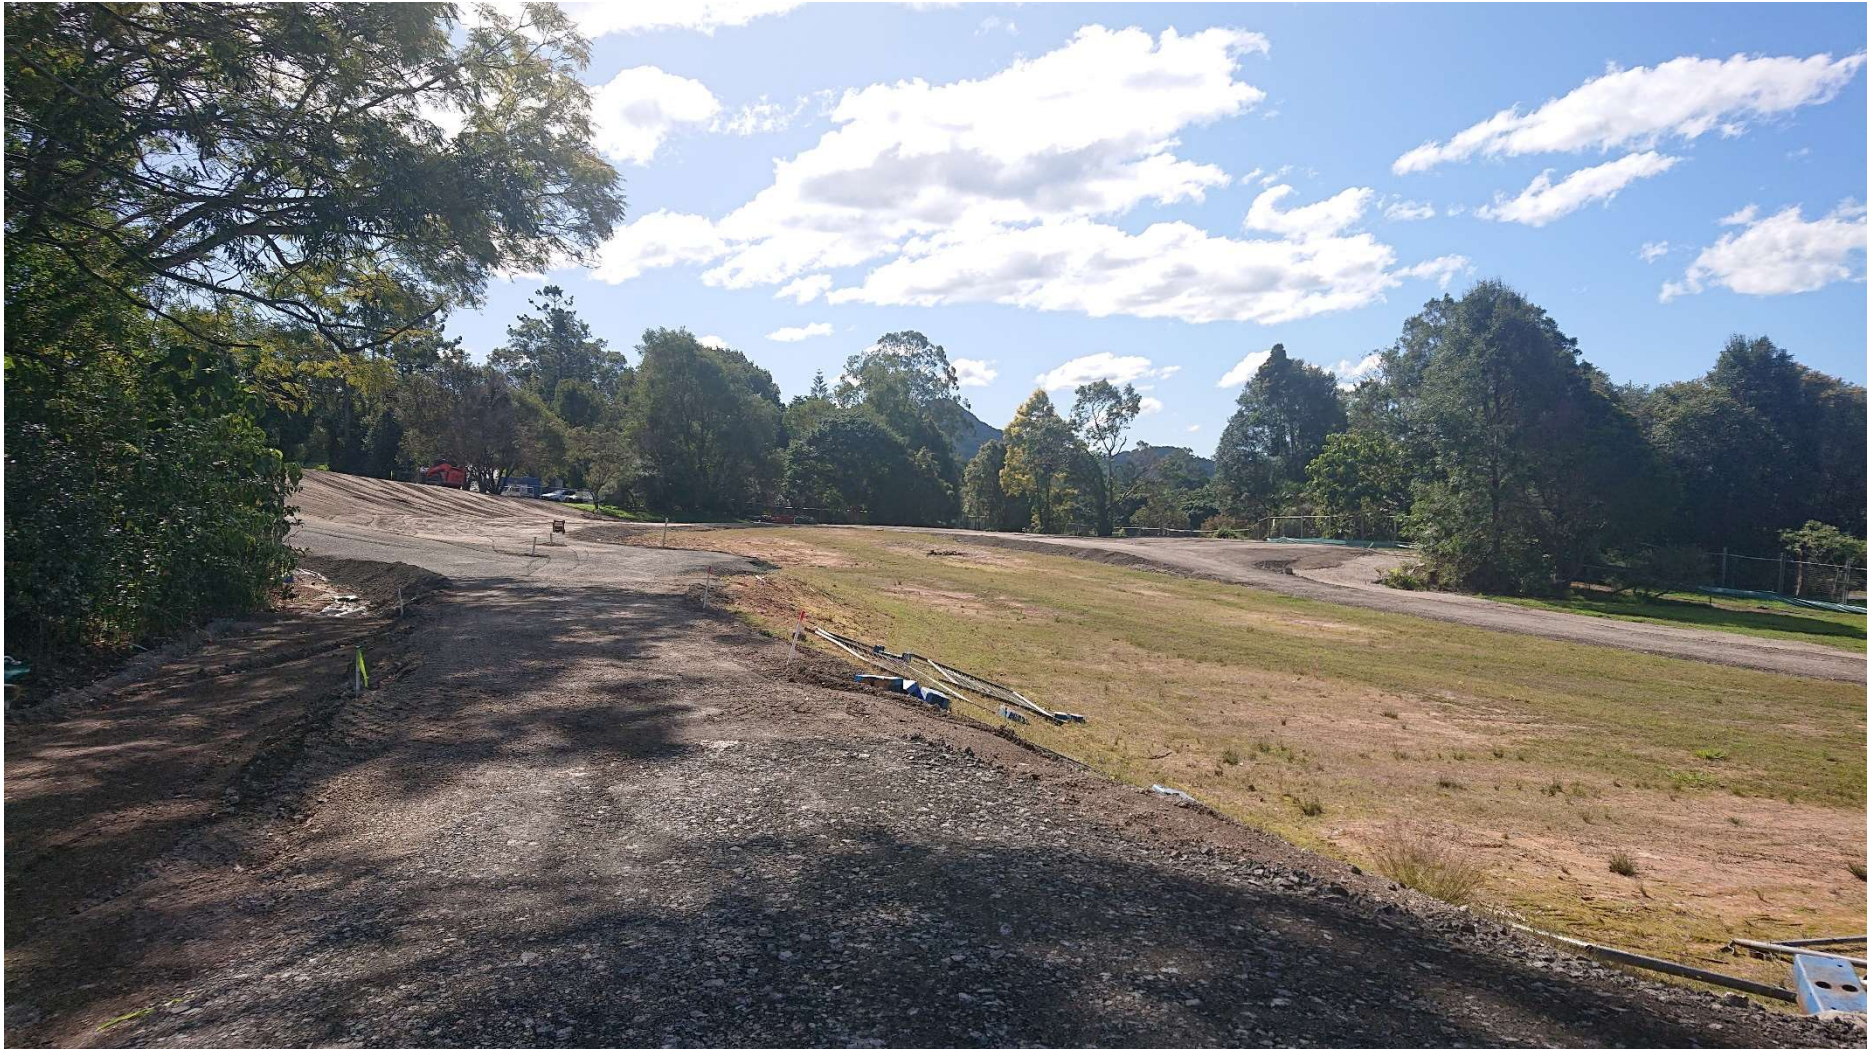
Plate B6. Northerly view of western section of encapsulation area (overlooking Block A) (16th August 2022)

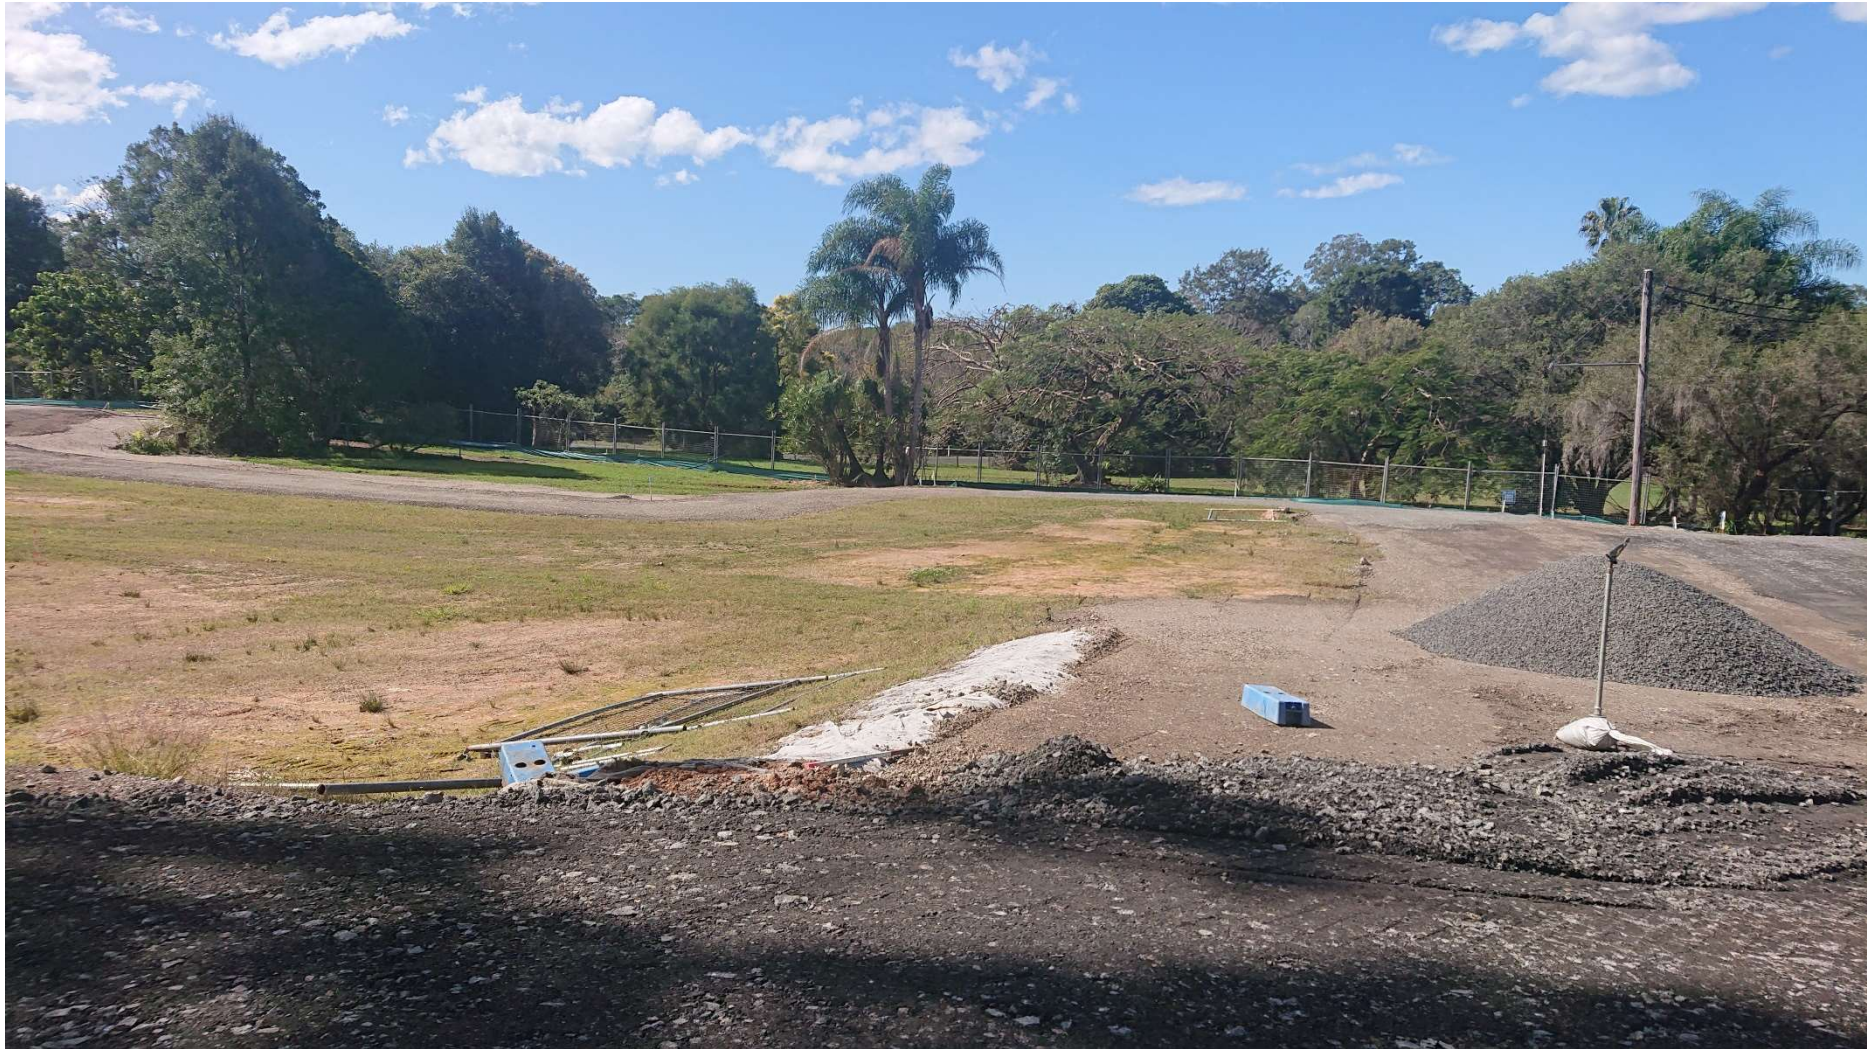
Plate B7. Easterly view of southern section of encapsulation area (overlooking Block A) (16th August 2022)

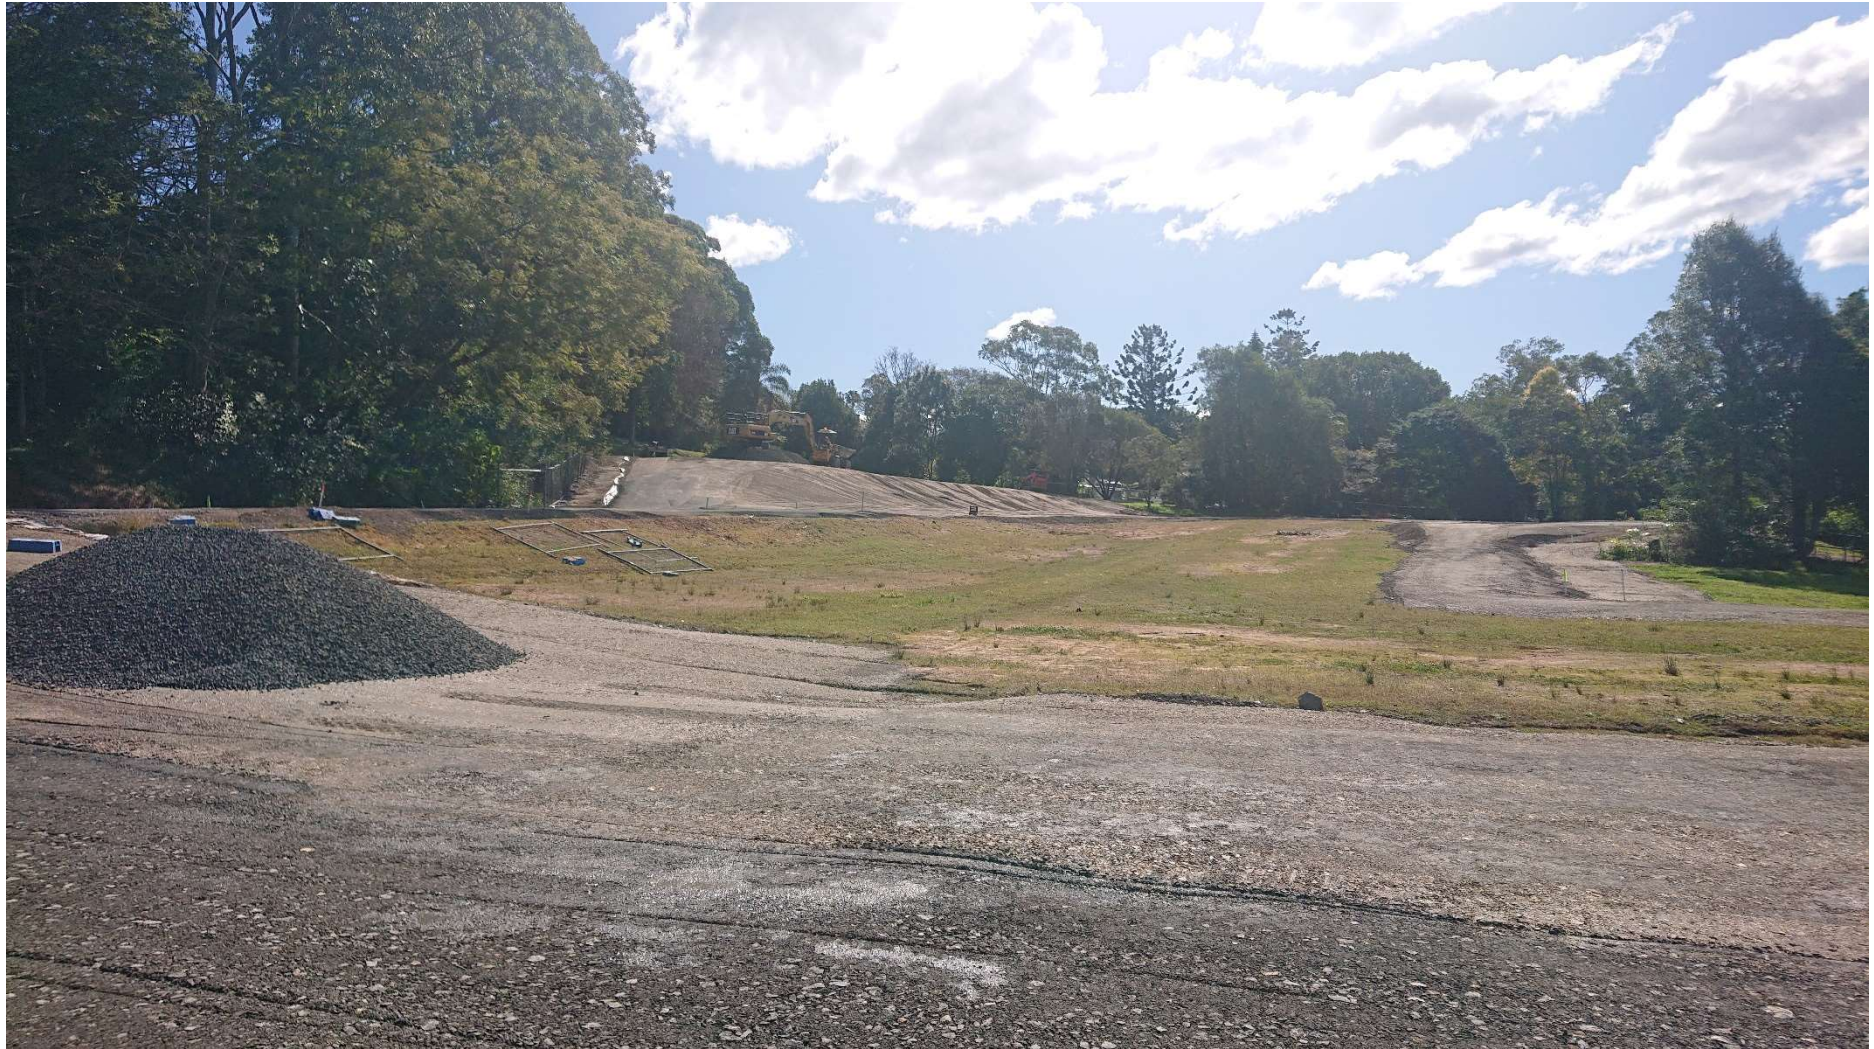
Plate B8. Northerly view of encapsulation area - overlooking Block A (grassy area) with Block C in top left and Block B in right (near tree) (16th August 2022)
