Succession Plan for Trees in Bangalow Village Streetscape (DRAFT)

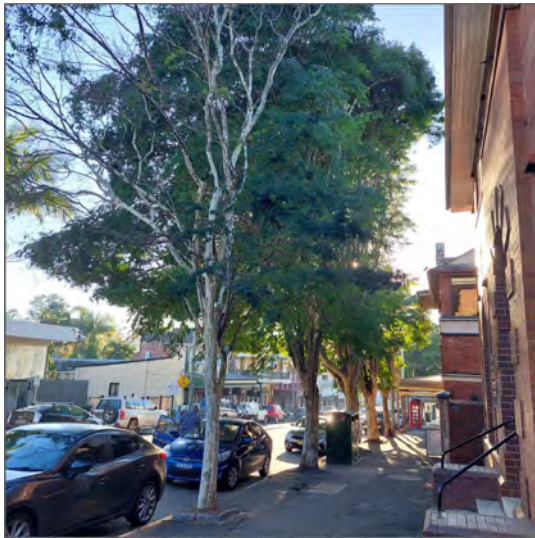
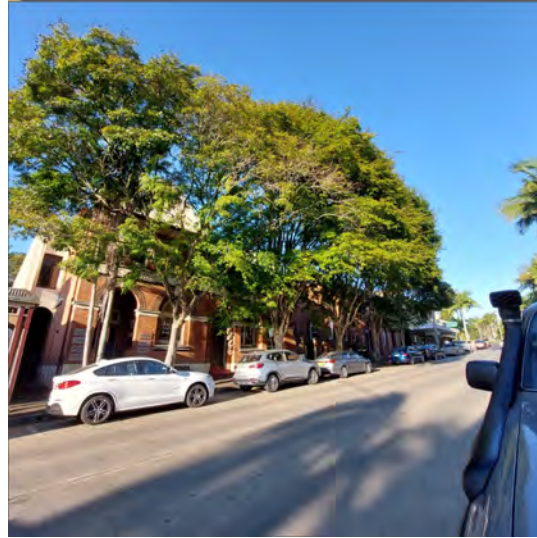
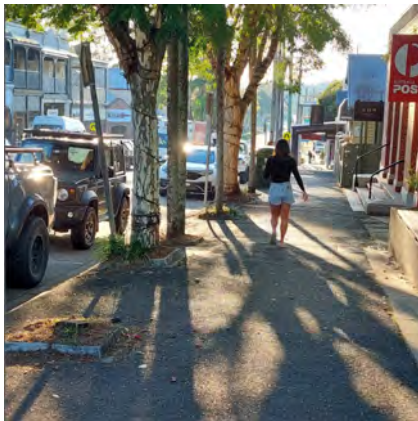
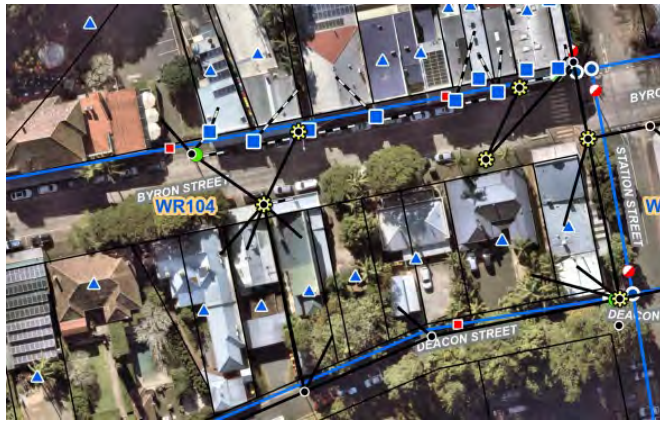
As can be seen in the above photos, the pavement is being severely disturbed by tree roots, fears have been raised by the Bangalow Historic Society that these roots could also be damaging the foundations of the proximal heritage buildings.

As well as the damage caused by roots, the owners of the neighbouring buildings report that the constant shedding of very fine leaves fills and blocks roof guttering (even with gutter guard) leading to water ingress and damage to stock. Council annually prunes foliage away from these buildings, it is a disruptive and expensive process requiring traffic and pedestrian control.

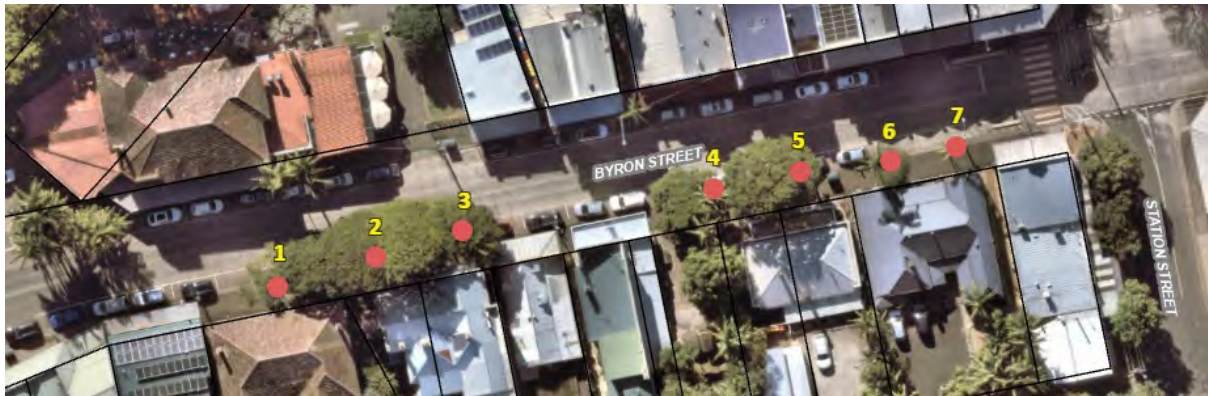
In all options the plantings will be in the outer edge of the footpath as existing. Planting pits will be carefully prepared to accommodate long-term growth with minimal pavement

disturbance. WSUD measures can be incorporated in the design to divert measured amounts of water from the gutter to the root ball.

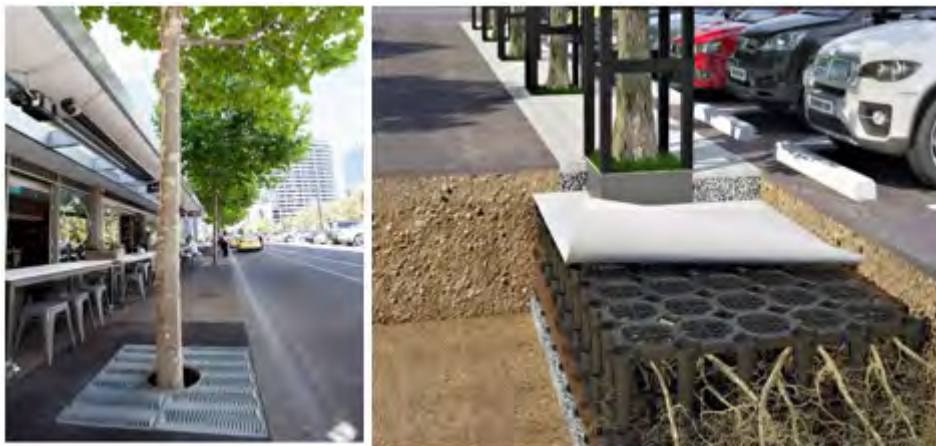
A tree surround like this, allows infiltration of air & water, is pedestrian friendly and can be customised to suit Bangalow heritage themes. Subsurface structural cells protect from soil compaction and accommodates lateral root growth.

Where council has installed this system for a dedicated root zone, trees have performed well and have not lifted pavement.

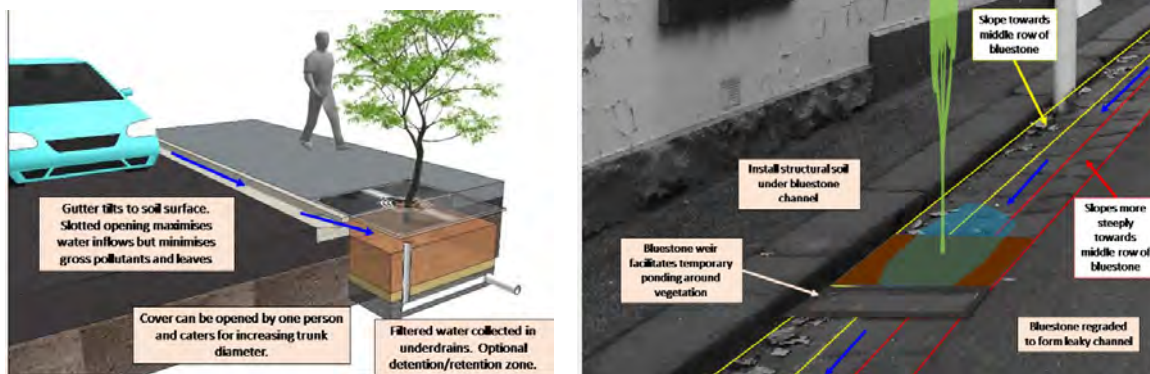
If construction of planting pits is pursued there is an opportunity to incorporate USUD which will irrigate trees while reducing the volume of stormwater entering local waterways.

Two examples of WSUD

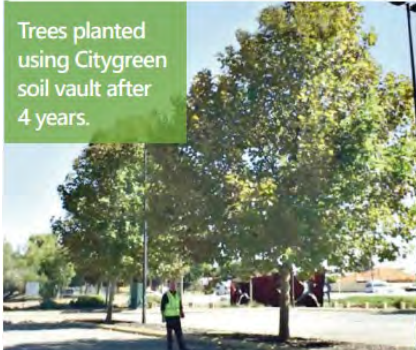
<p>Trees planted using Citygreen soil vault after 4 years.</p>

Some indications of cost (and value) can be speculated from the table below. As can be seen by this example, if following traditional methodology of simply placing a tree in a hole of native material, costs will be lower but the tree will develop much more slowly and problems with pavement disruption are likely to reoccur.

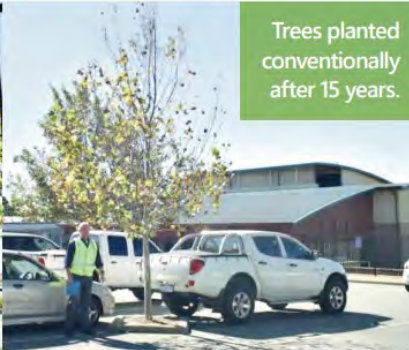
<p>Trees planted conventionally after 15 years.</p>

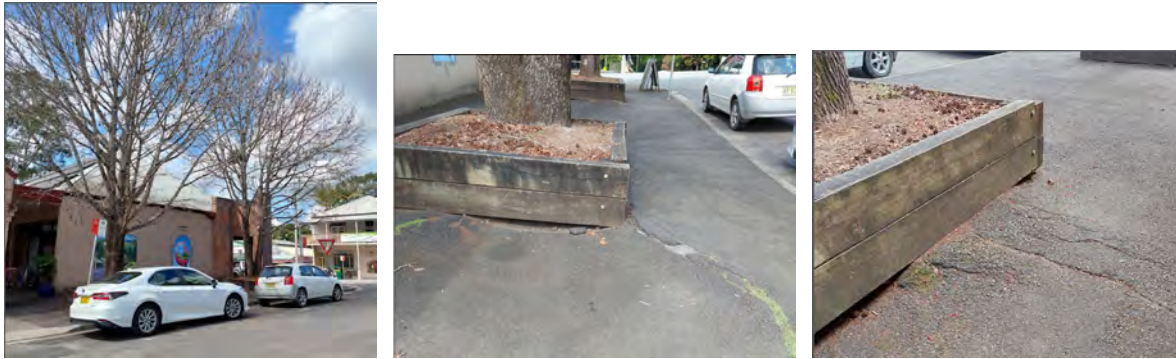
These trees could double in size in coming years if allowed to remain.

Other trees in the Bangalow streetscape that are causing problems are 2 *Liquidambar styraciflua* on Station St. These trees have a vigorous root system renowned for disrupting pavement and services. Approximately 10 years ago the pavement became so uneven that the whole surface was removed to allow pruning of roots and then relayed, timber surrounds were built to keep pedestrians away from root flares emanating from the trees.

The problem is reoccurring, and the owner of the adjacent premises has concerns that the roots may be damaging his building. To reduce the cost of ongoing maintenance it is suggested that they are removed and replaced by a less aggressive local species. There is

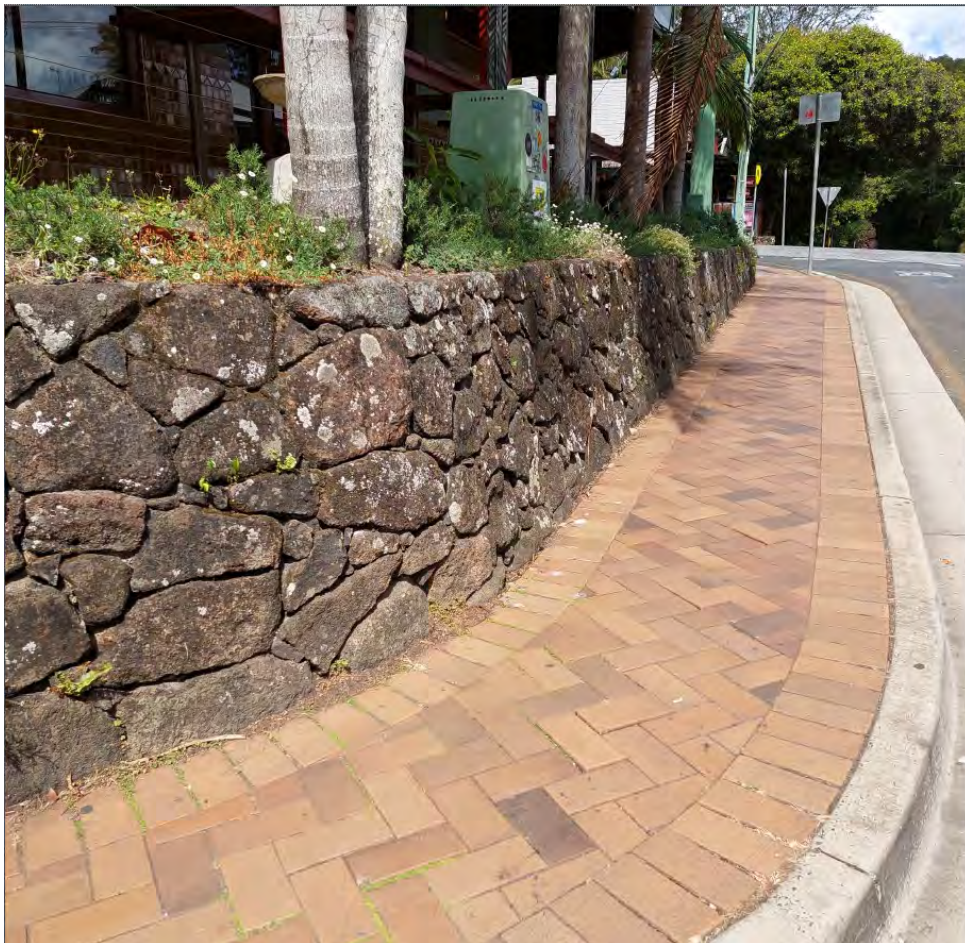
Replace planter boxes on Station St with local basalt at seating height to match the feature wall opposite.
